TRANSPORTATION RESEARCH CENTER

**ON-SITE AIR BAG INVESTIGATION**

CASE NO. - 95-18  
FLEET - COMMERCIAL VEHICLE  
LOCATION - [REDACTED] PENNSYLVANIA  
ACCIDENT DATE - [REDACTED] 1995

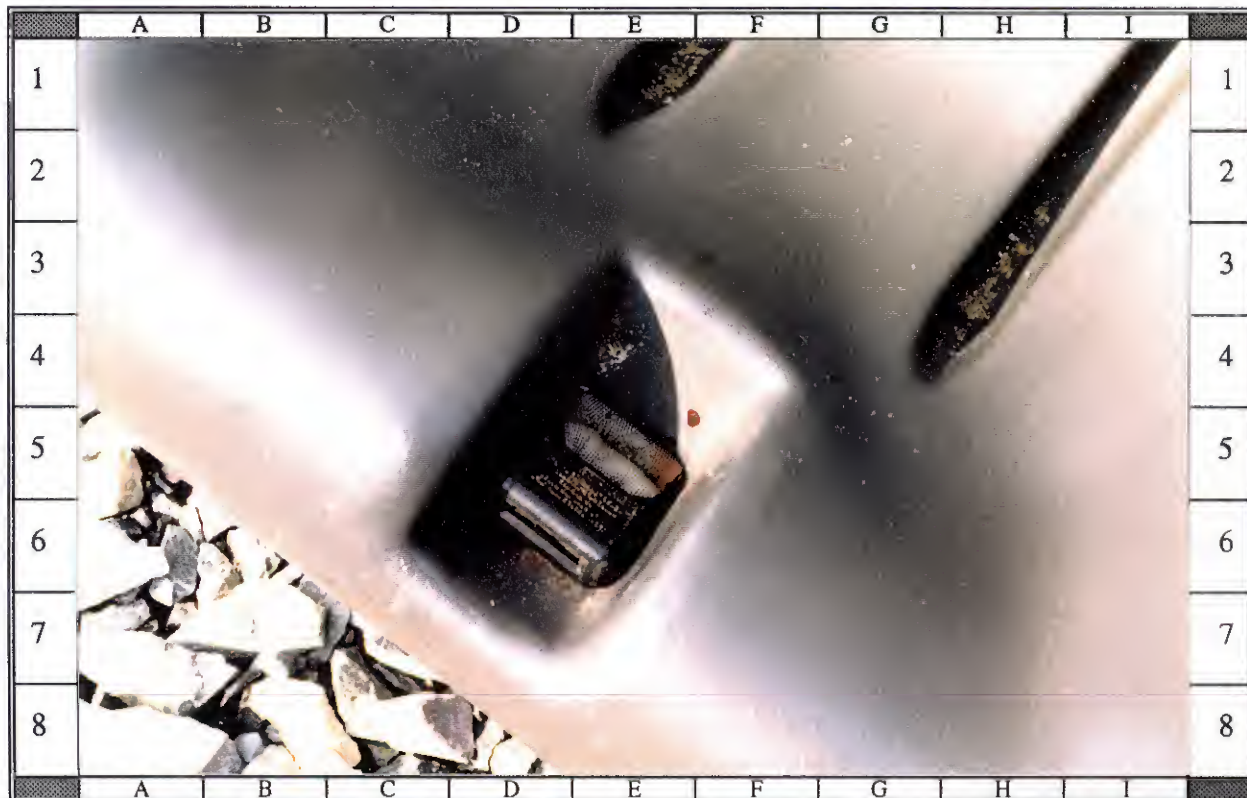
# 51 -- Century Breverra child booster seat's plastic shell with padding pulled away;  
NOTE: blood drop near harness clasp (cells G4--G5)

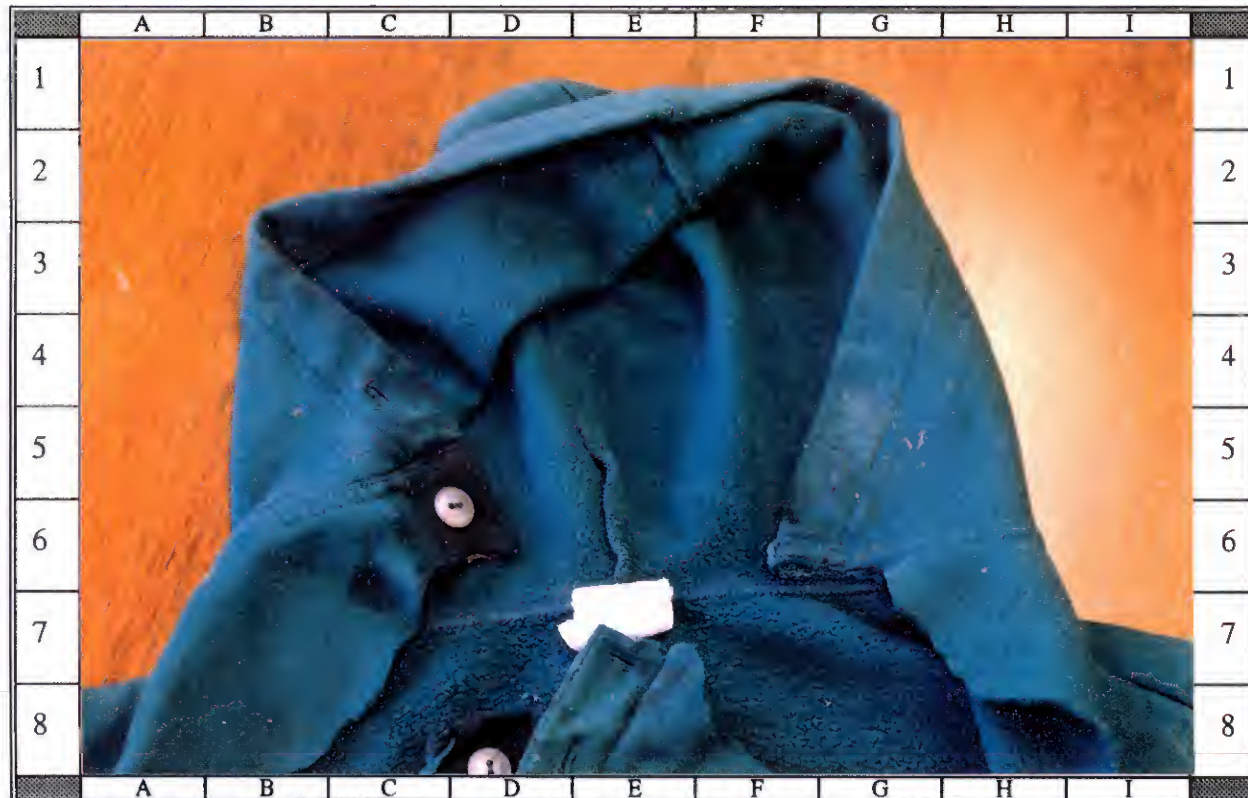
**# 53 -- Bloodied sweatshirt worn by child in Case Vehicle's right front seat; NOTE: EMT personal cut sweatshirt off child**

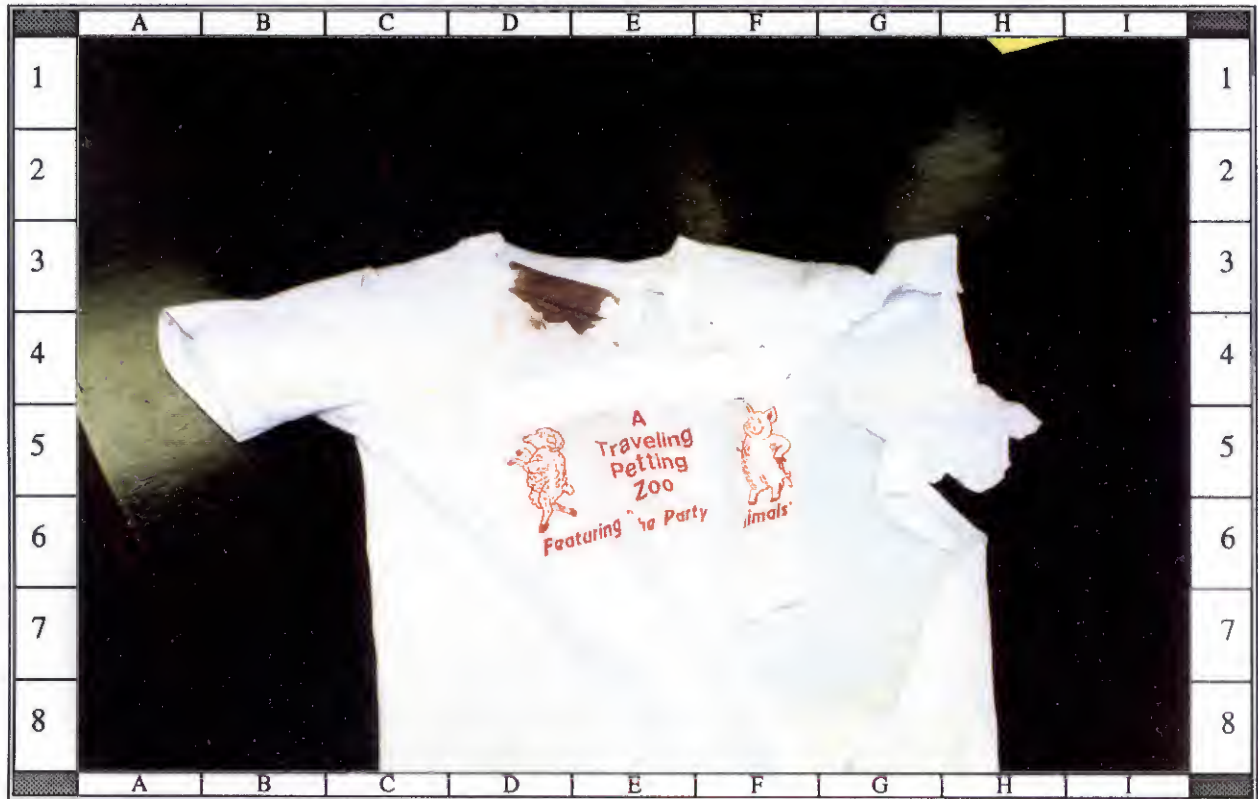
**# 54 -- Close-up of bloodstains (cell C5--D6) and unknown substance to neckline of sweatshirt worn by Case Vehicle's child occupant**

According to National Transportation Safety Board (NTSB) personnel<sup>8</sup>, testing done on the child's sweatshirt (see **SELECTED PHOTOGRAPH #54**) confirmed the presence of blood, but unfortunately, the unidentified flakes on the left neckline, which appeared to be skin, could not be positively identified. It should be noted that no other evidence of contact was found in the case vehicle other than to the air bag itself. The child's primary injuries were to his brain with soft tissue injuries to his face, shoulders, and chest.

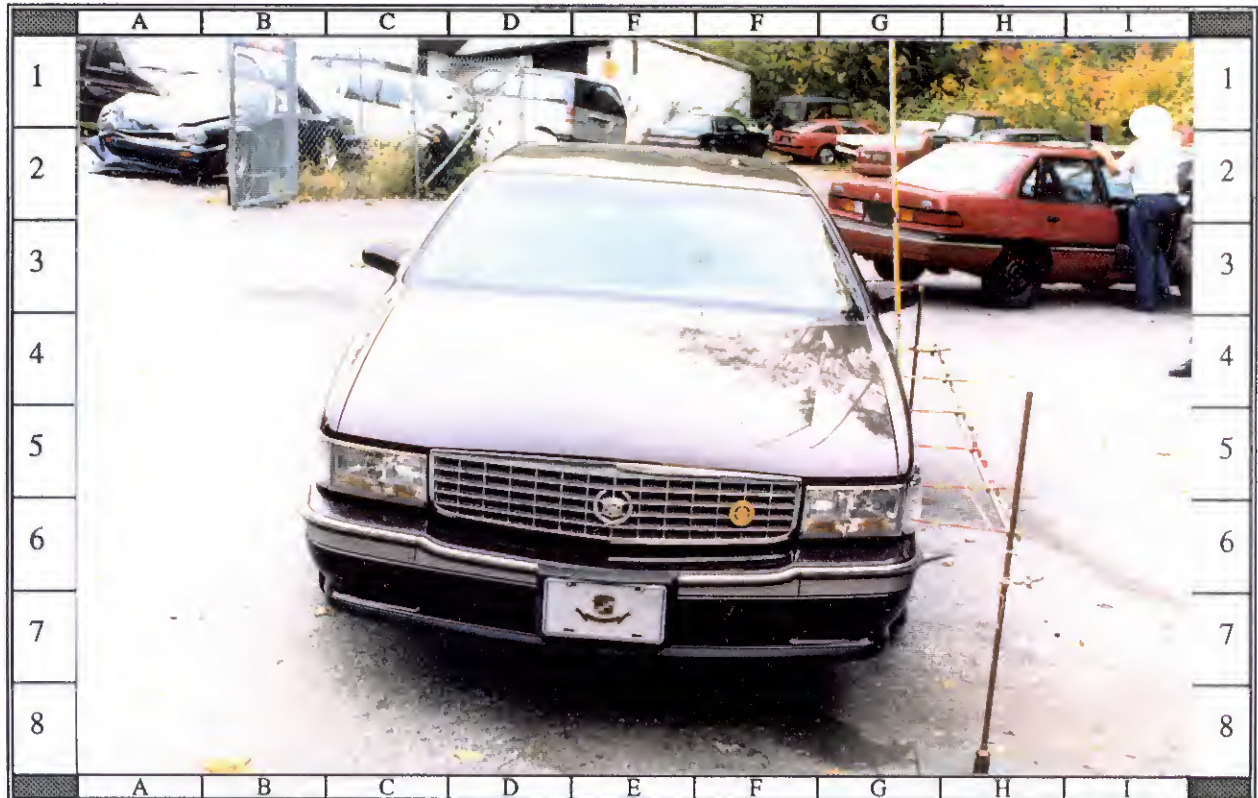
# 55 -- Bloodied T-shirt worn by Case Vehicle's right front child occupant

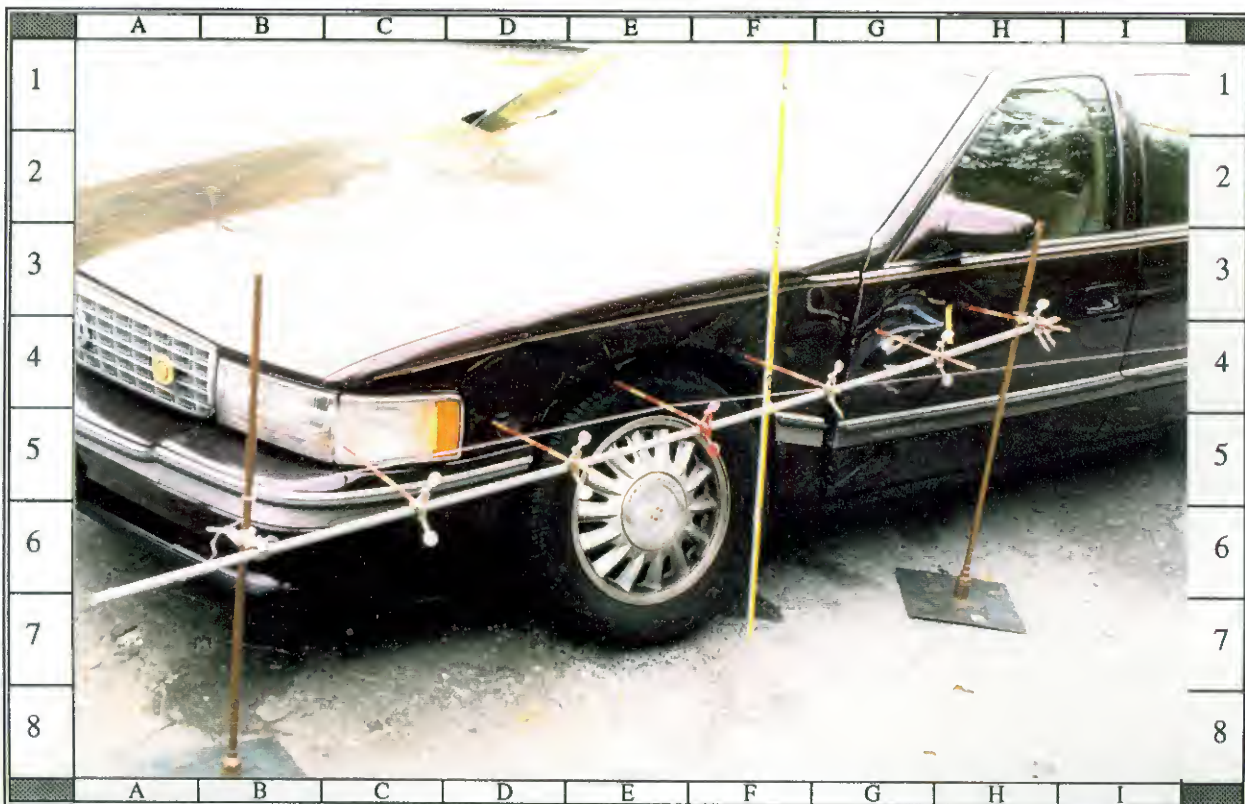
# 57 -- Reference line view of Vehicle #2's left side from front showing crush profile

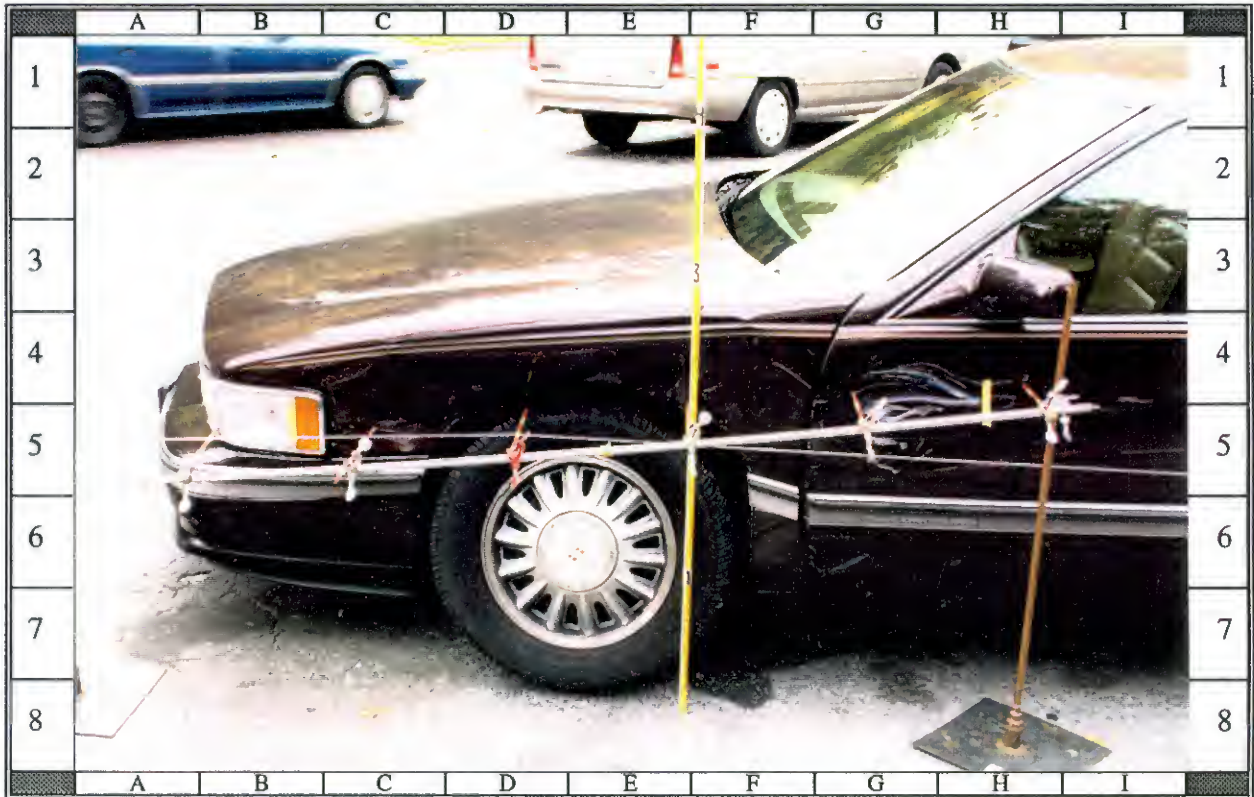
# 61 -- Vehicle #2's damaged left fender, wheel, and door with contour gauge present;  
NOTE: max crush to wheel well area and direct contact to hubcap

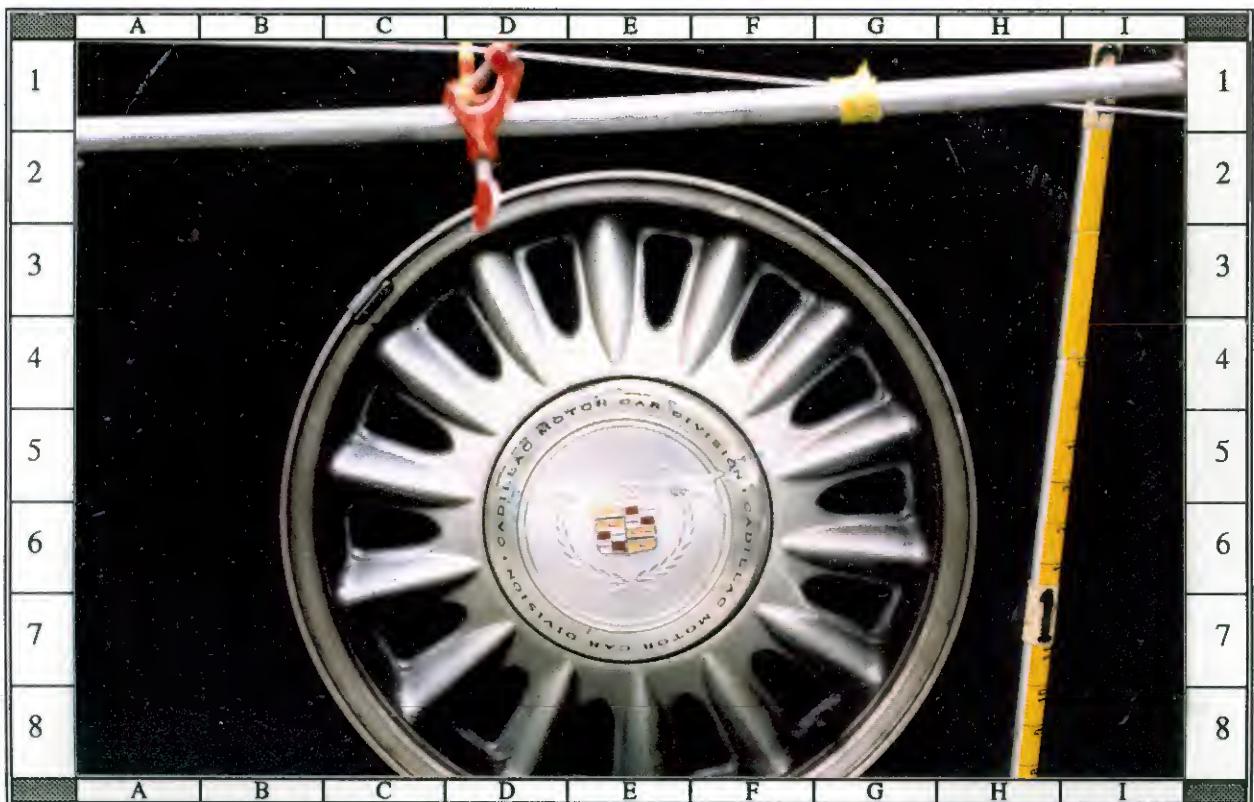
# 62 -- Close-up of direct damage to left front wheel/hubcap of Vehicle #2; NOTE:  
paint transfer from case vehicle (see PHOTO #27)

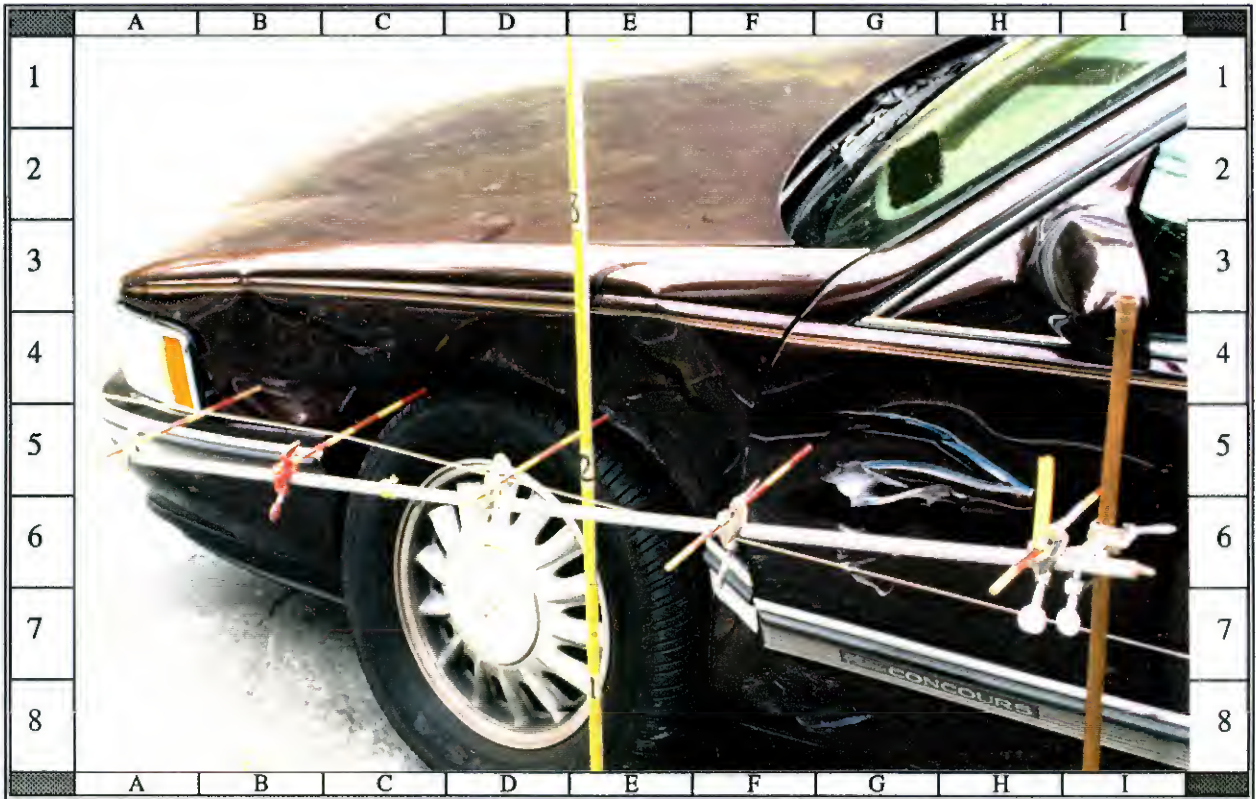
# 63 -- Close-up of Vehicle #2's left side damage viewed from approximately 60 degrees left of rear

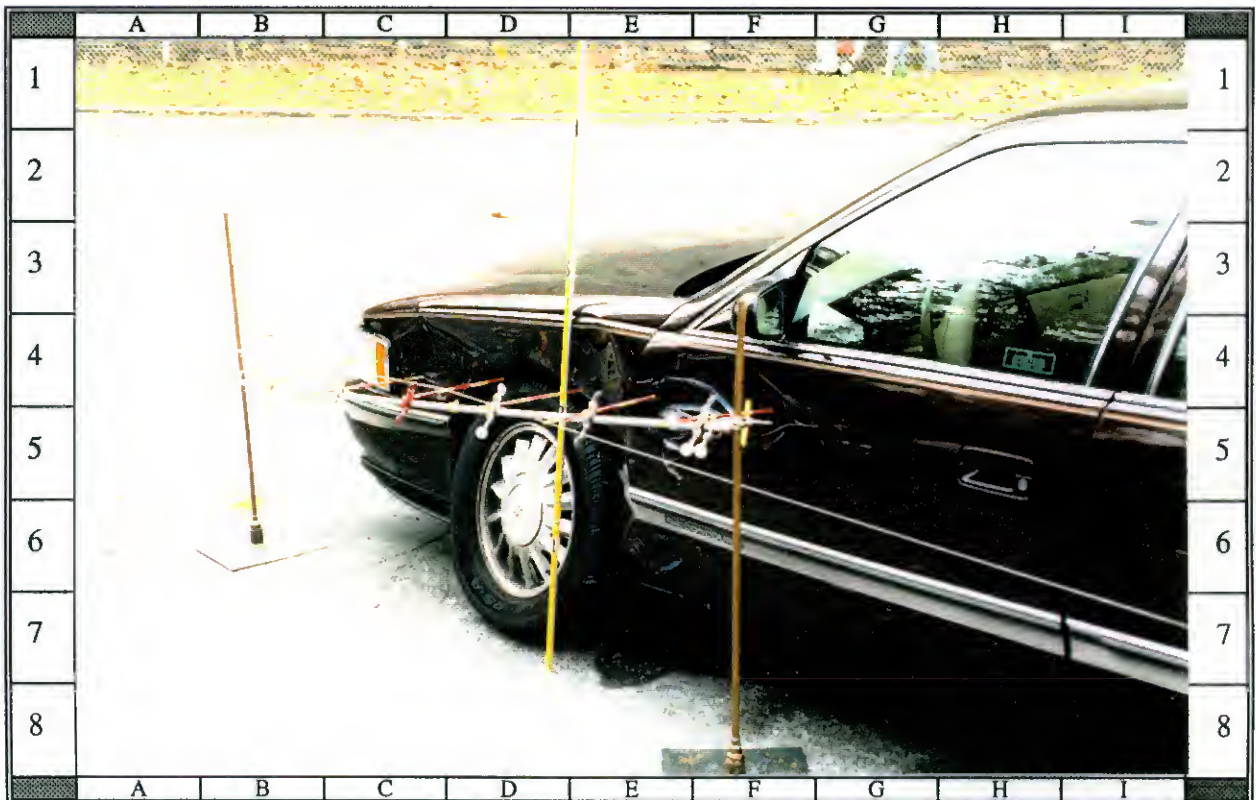
# 64 -- Vehicle #2's left side damage viewed from ~ 60 degrees left of rear; NOTE: left front wheel's inward tilt

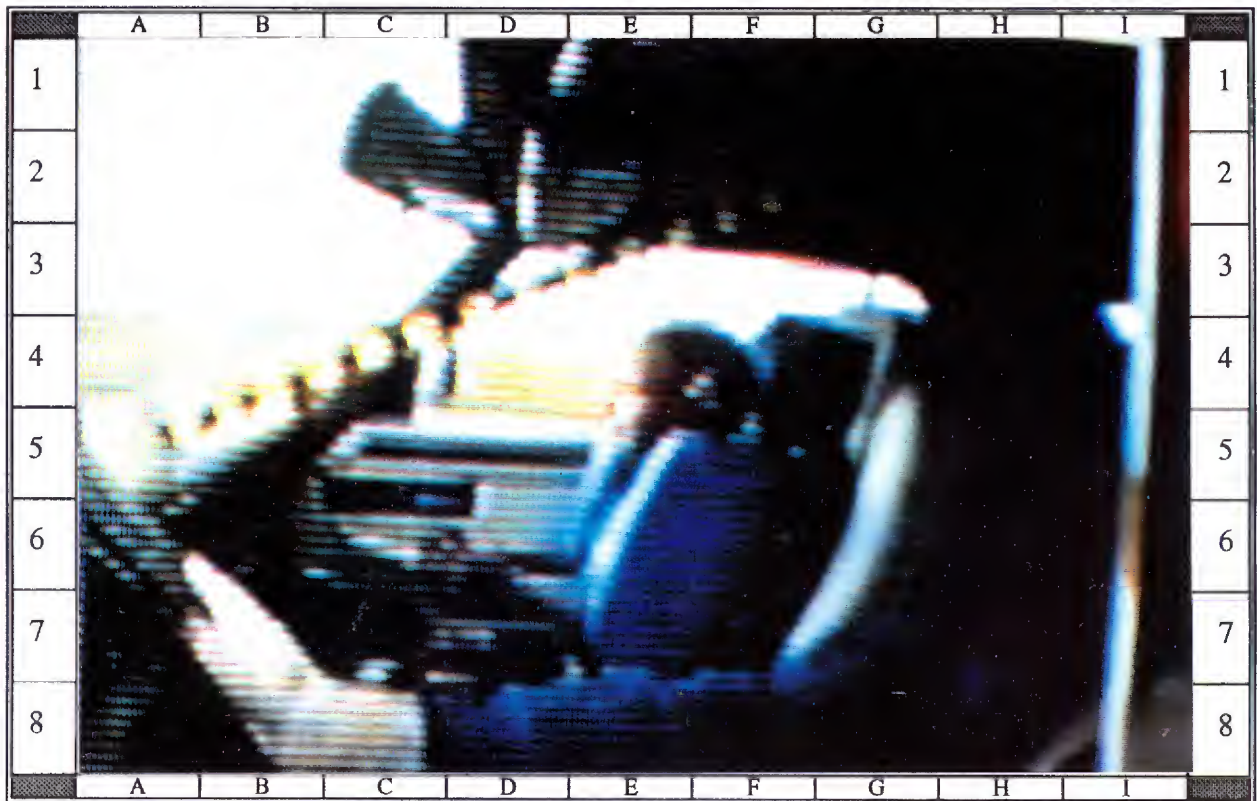
**# 73 -- VRTC's Run #6: child in pre-crash test position--torso belt snug over top of add-on head bolster**

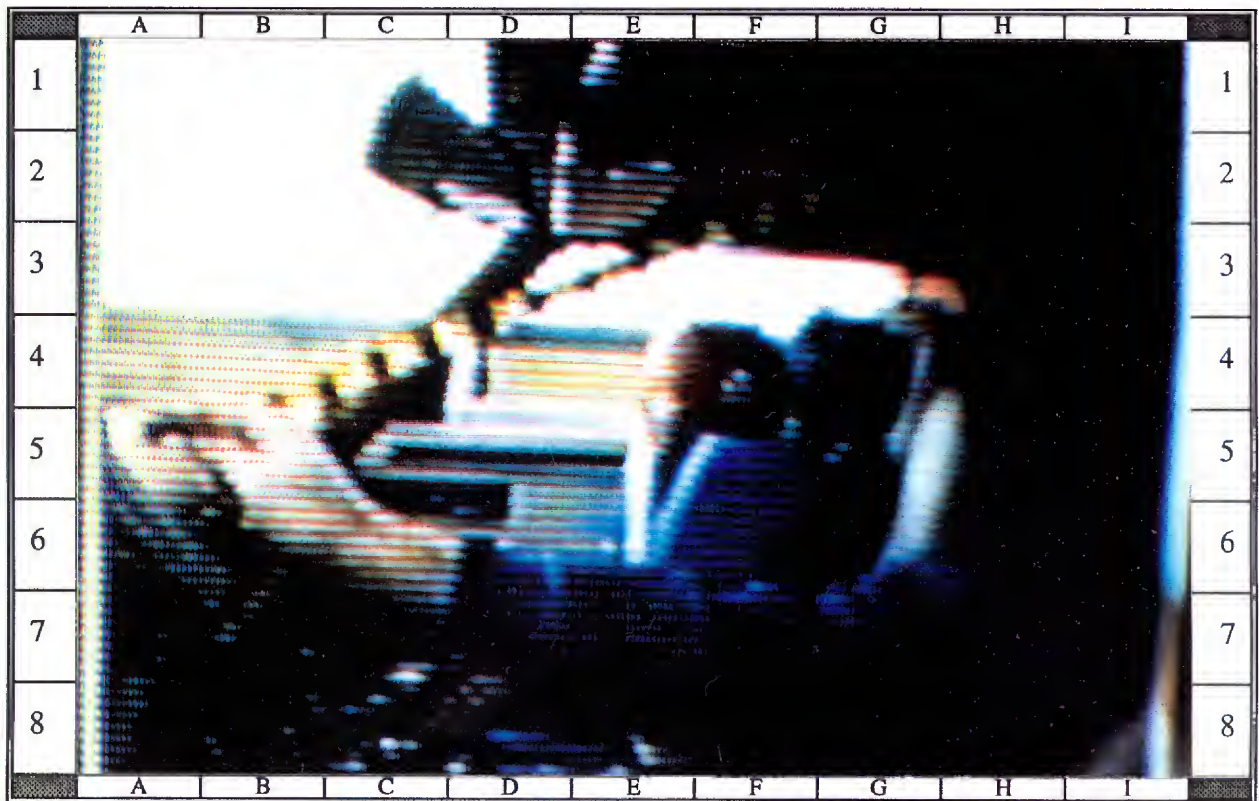
**# 75 -- VRTC's Run #7: child in pre-crash test position--torso belt snug over top edge of add-on head bolster's side**

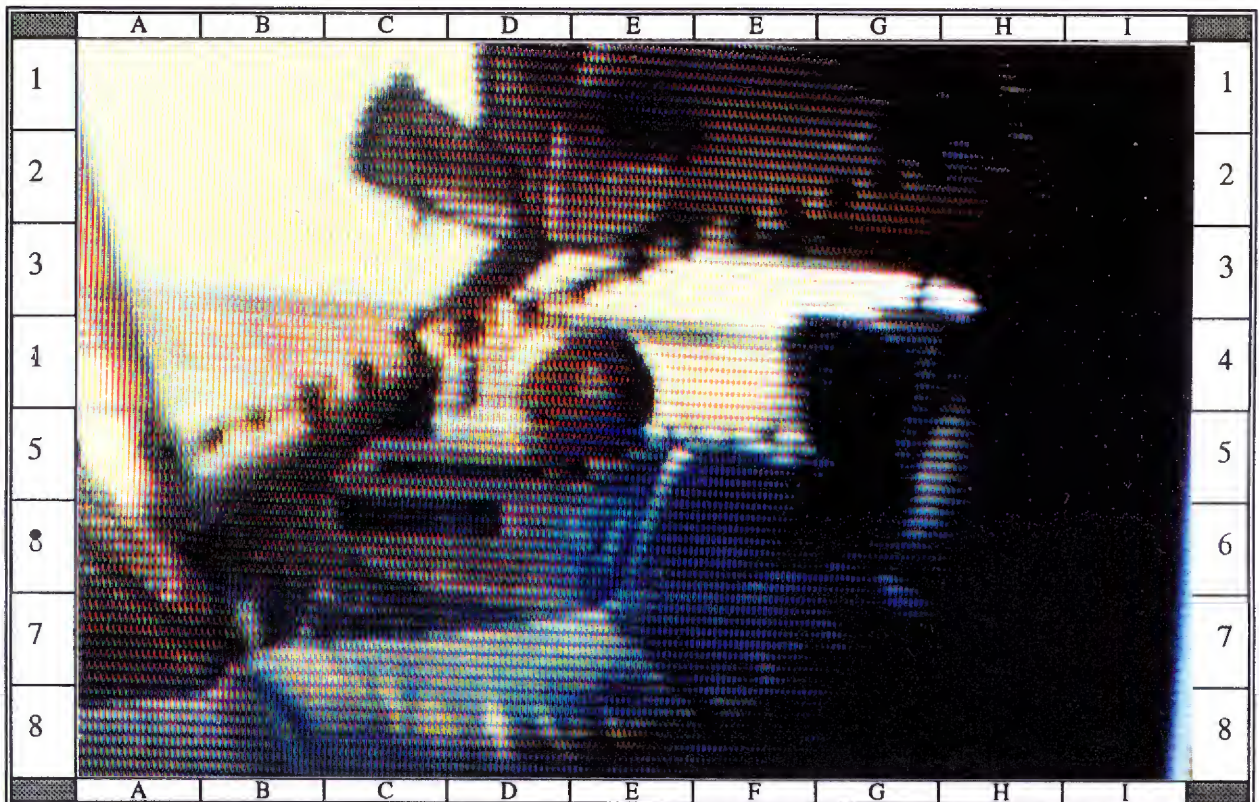
**# 76 -- VRTC's Run #7: decelerating @ .08g and swerving left; child's maximum forward position--torso belt snug over top edge of add-on head bolster's side**
